EXPERIENCE WITH THE CZECH APPROACH TO PREVENTIVE MEASURES AGAINST RADON

– ANALYSIS OF FAILURES

Matej Neznal, Martin Neznal

RADON v.o.s., Novakovych 6, 180 00 Prague 8

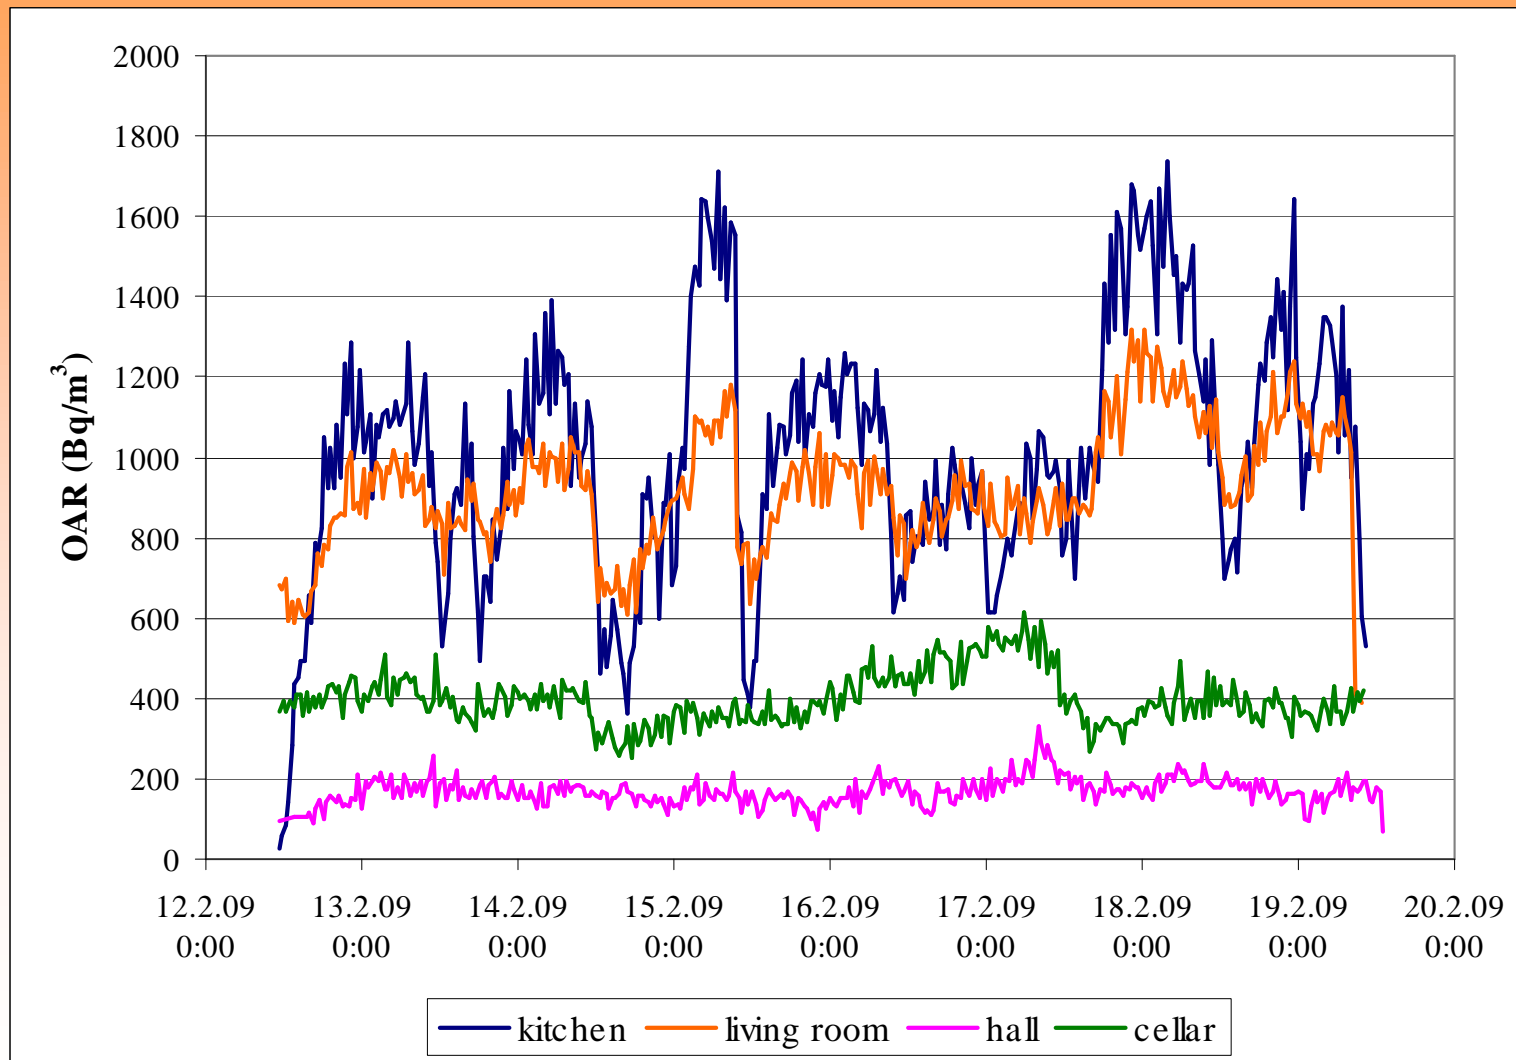
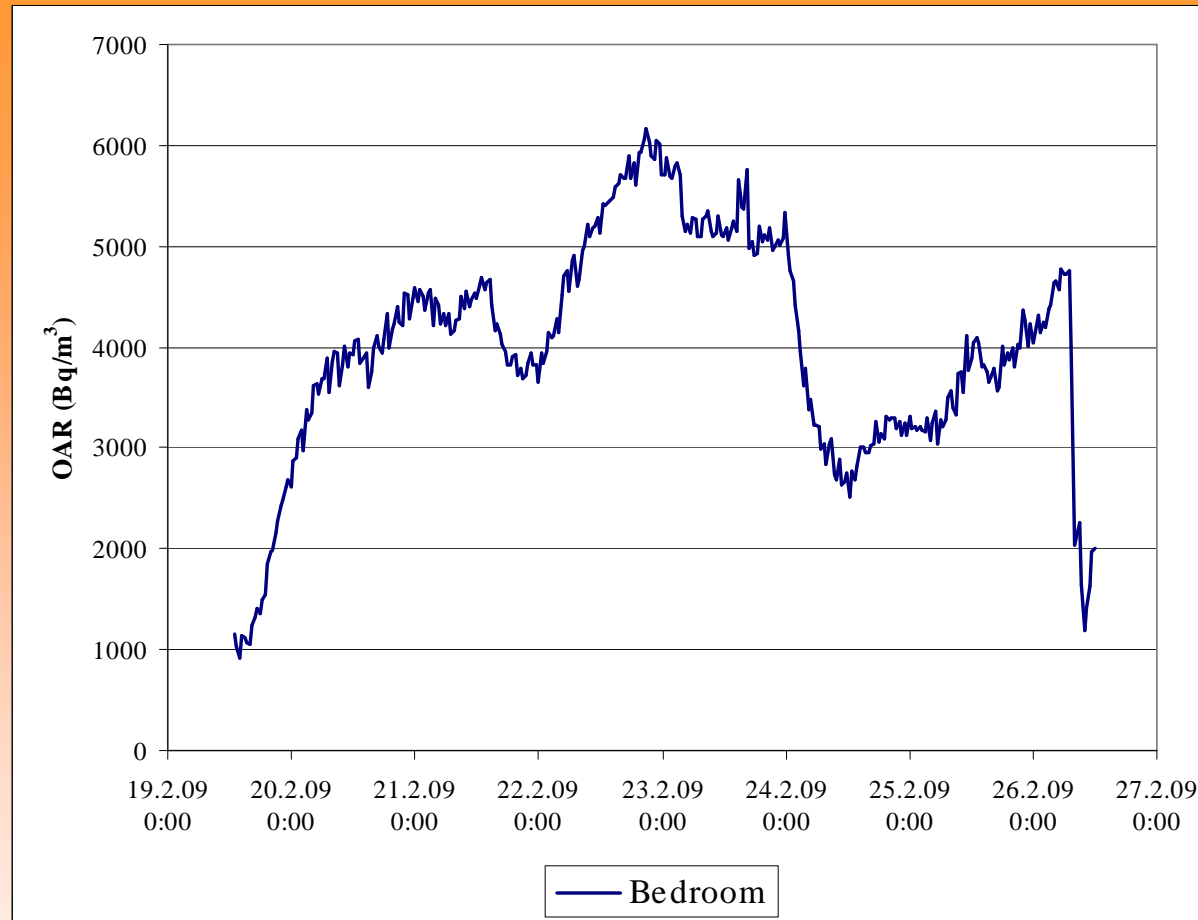
Simultaneous one week continual measurements in different parts of the house

-the indoor radon dynamic study

Average values:

Room – floor		[Bq.m ⁻³]
Bedroom – ground floor		4010
Kitchen – ground floor	1011	
Living room – ground floor		924
Hall - ground floor		169
Cellar		399

Reasons for higher indoor radon concentrations:

- **radon index assessment was not performed;**
- **the preventive measures were designed insufficiently, because they corresponded to the medium radon index (radon-proof membrane without any subslab ventilation or another combination due to the Czech National Standard);**
- **imperfections occurred during the construction; some joints of the membrane were not sealed perfectly and the membrane was probably also punctured during the construction of the floor.**

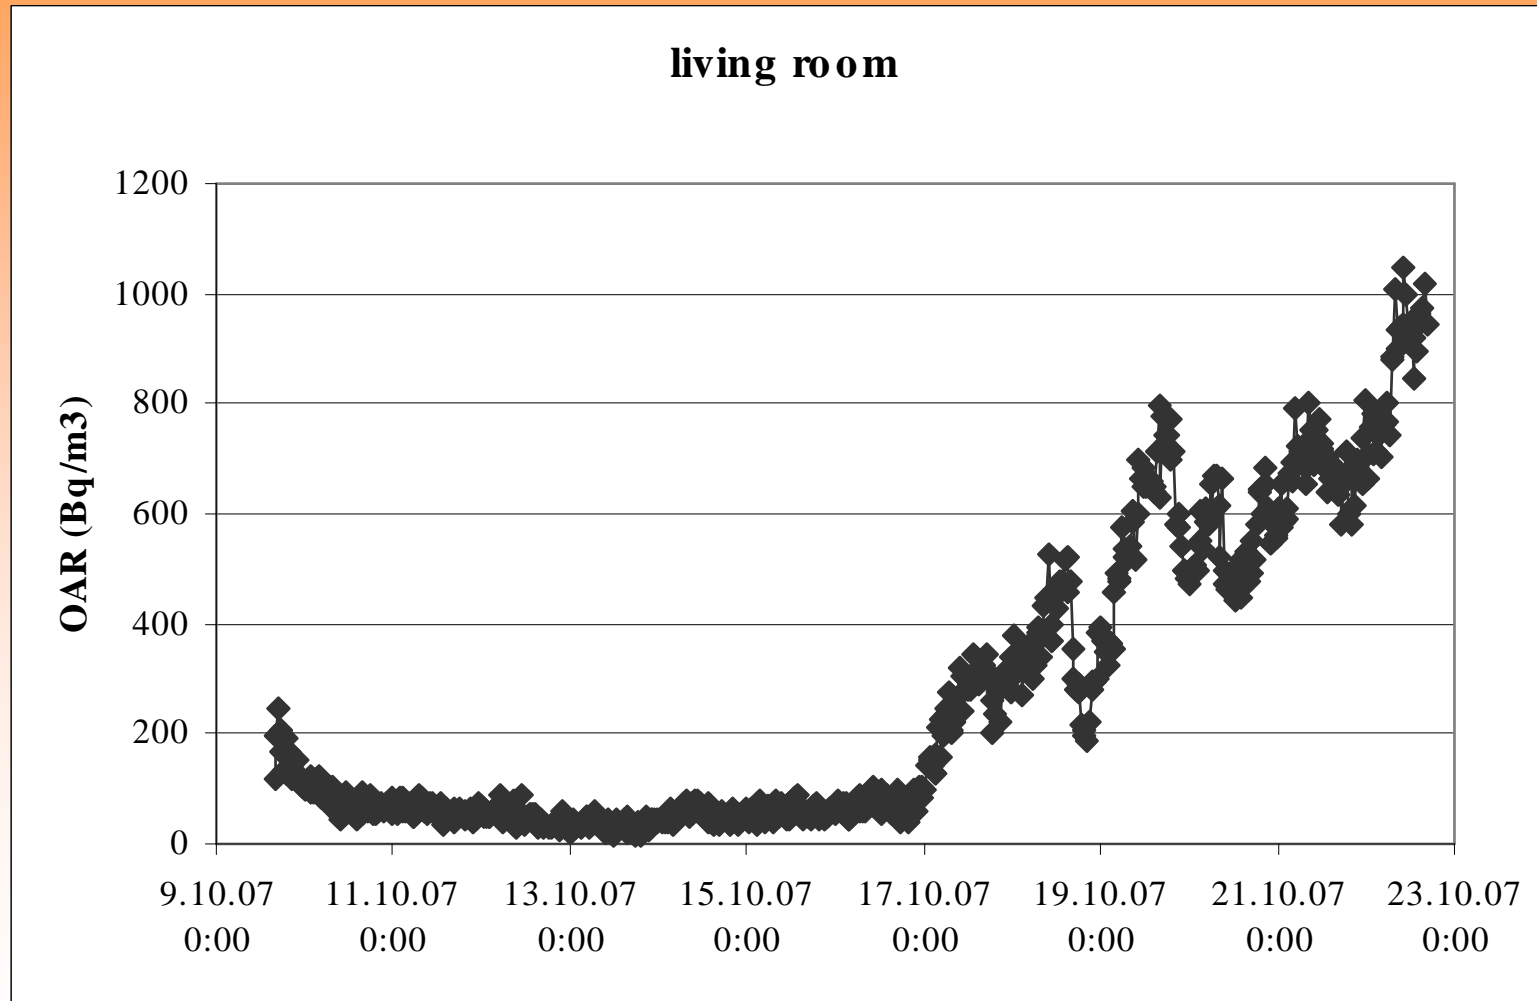
Ventilation experiment

Indoor radon concentration (Bq.m ⁻³)
room „2“	237
living room (+ hall + kitchen)	266
study room	185
room „1“	182

room „2“	62
living room (+ hall + kitchen)	62
study room	72
room „1“	97

room „2“	460
living room (+ hall + kitchen)	512
study room	322
room „1“	285

Ventilation experiment – simultaneous continual measurements of radon concentration in different parts – living room

For remediation, the most effective solution based on the installation of a sub-slab depressurization was chosen and realized. The soil gas was sucked from perforated tubes drilled into the sub-floor layer from the external trench excavated in the ground along a part of the house.

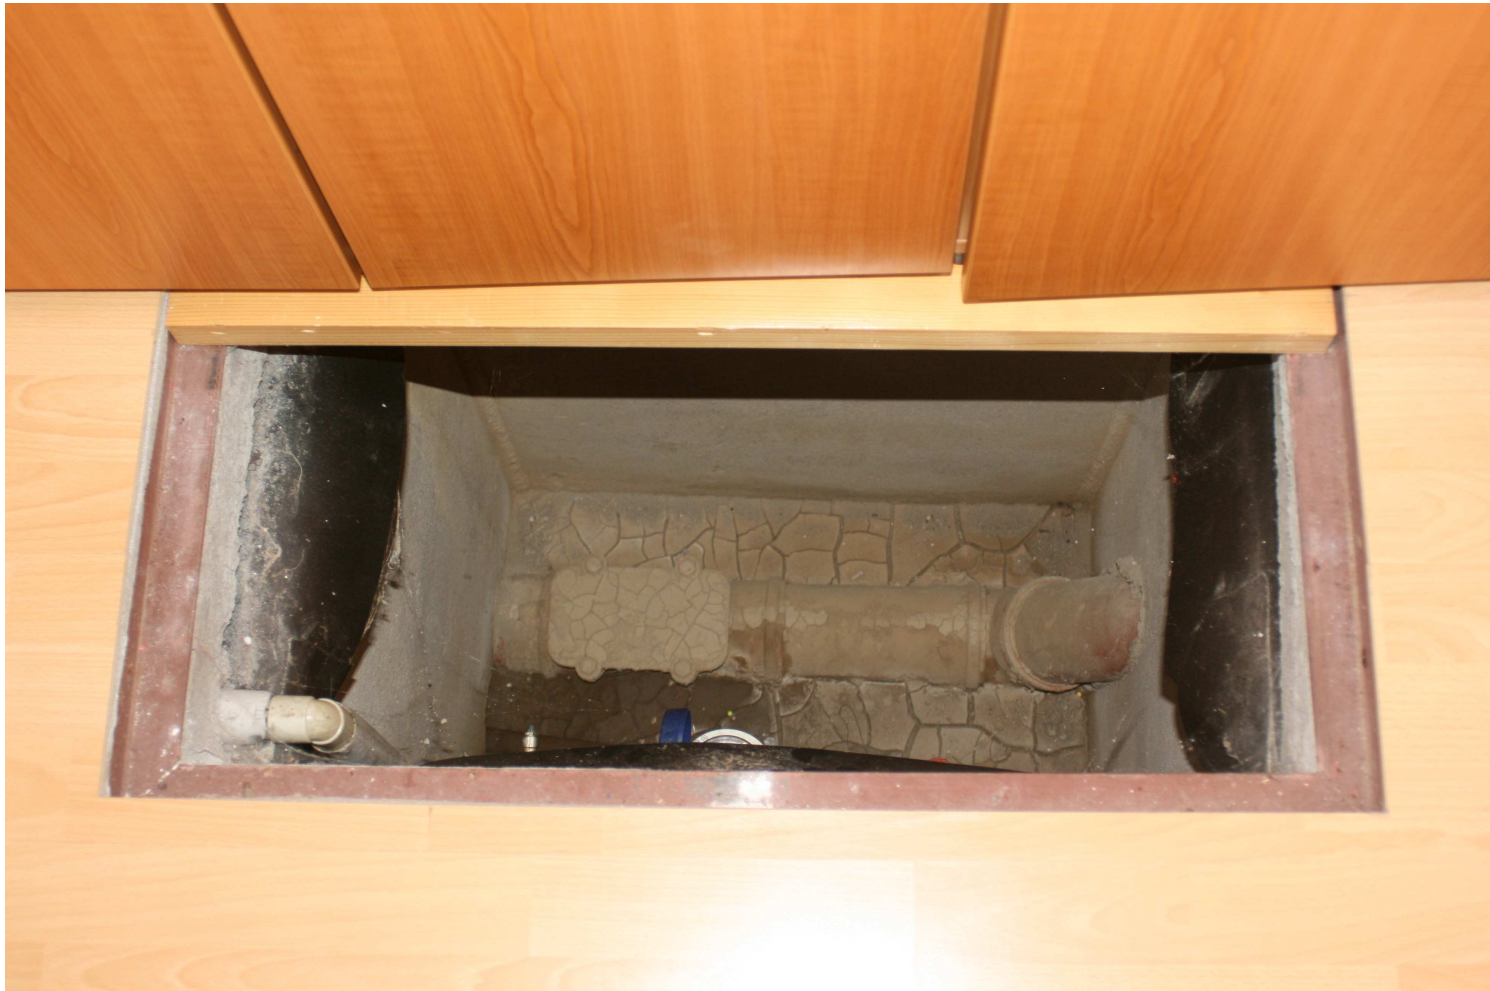
During the visual inspection of the building (mainly of the construction at the contact between the sub-soil and the building and of visible cracks and leakages) we have found an uninsulated non-sealed inspection chamber under the trap door in the study room under the linoleum. The radon proof membrane was not jointed, probably the responsible person forgot to do it and nobody did not recall that detail.

When we sampled the air from the chamber, we received following results: 55,5 kBq.m⁻³ (sample just under the trap door); 84,5 kBq.m⁻³ (sample at the bottom of the chamber); 46,6 kBq.m⁻³ (sample under the edge of the membrane).

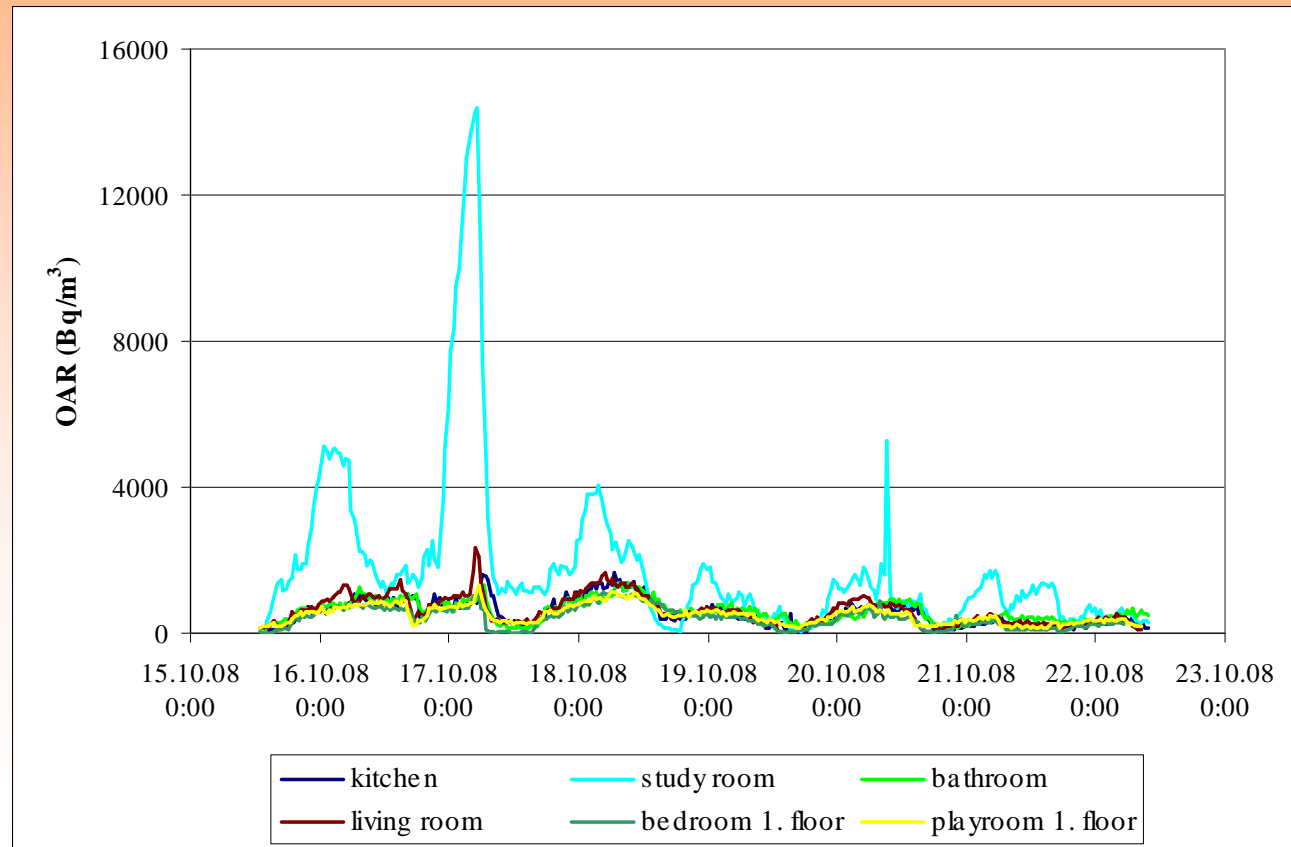
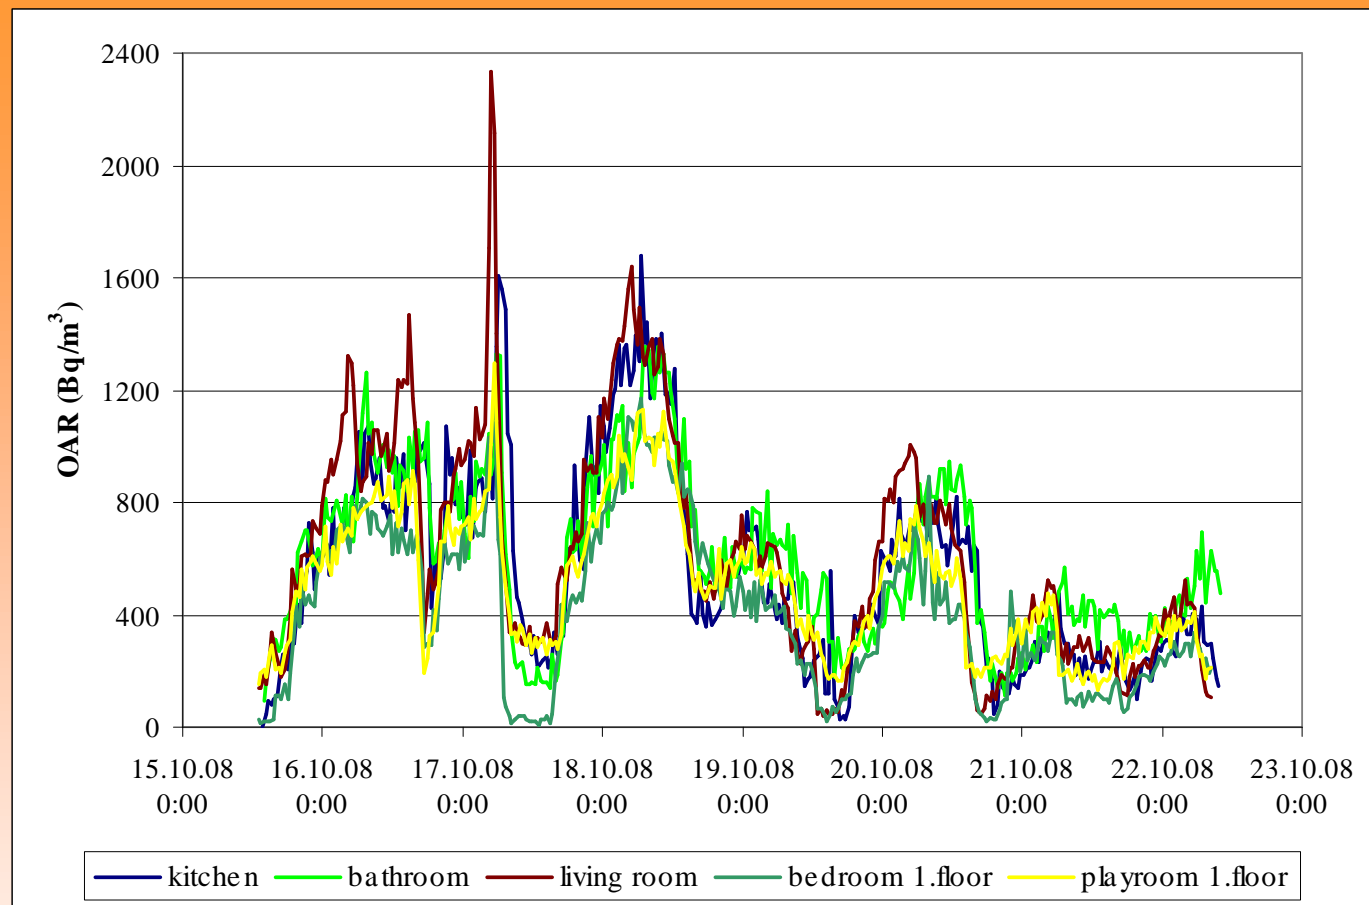
The main radon source was identified. Air sampling from selected locations (mainly leakages between the walls and floors) verified the radon pathways above the membrane from the chamber as well, but the main source is the air coming from the uninsulated chamber through the trap-door directly into the study room and subsequently to other rooms. Simultaneous continual radon monitoring confirmed those expectations.

Average values:

Study room – ground floor

1795
